YOUR ONESURVEY HOME REPORT

Whispering Pines Mawcarse Milnathort, Kinross KY13 9SJ

Single Survey

Surveyor Reference	DD0396
Customer	Mr & Mrs. Alisdair & Sandra Stewart
Selling address	Whispering Pines Mawcarse Milnathort, Kinross KY13 9SJ
Date of Inspection	13/03/2024
Prepared by	Peter Bennet, MRICS Dunfermline - Allied Surveyors Scotland Plc

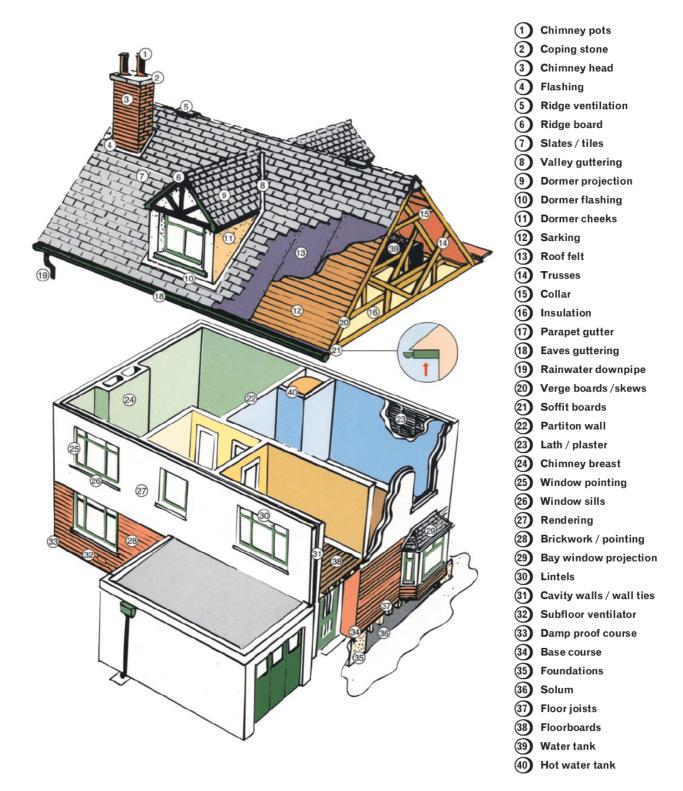
Sectional Diagram showing elements of a typical house

Reference may be made in this report to some or all of the above component parts of the property. This diagram may assist you in locating and understanding these items.
